The San Francisco Earthquake and Fire 1906

The
San Francisco Earthquake and Fire

A BRIEF HISTORY OF THE DISASTER

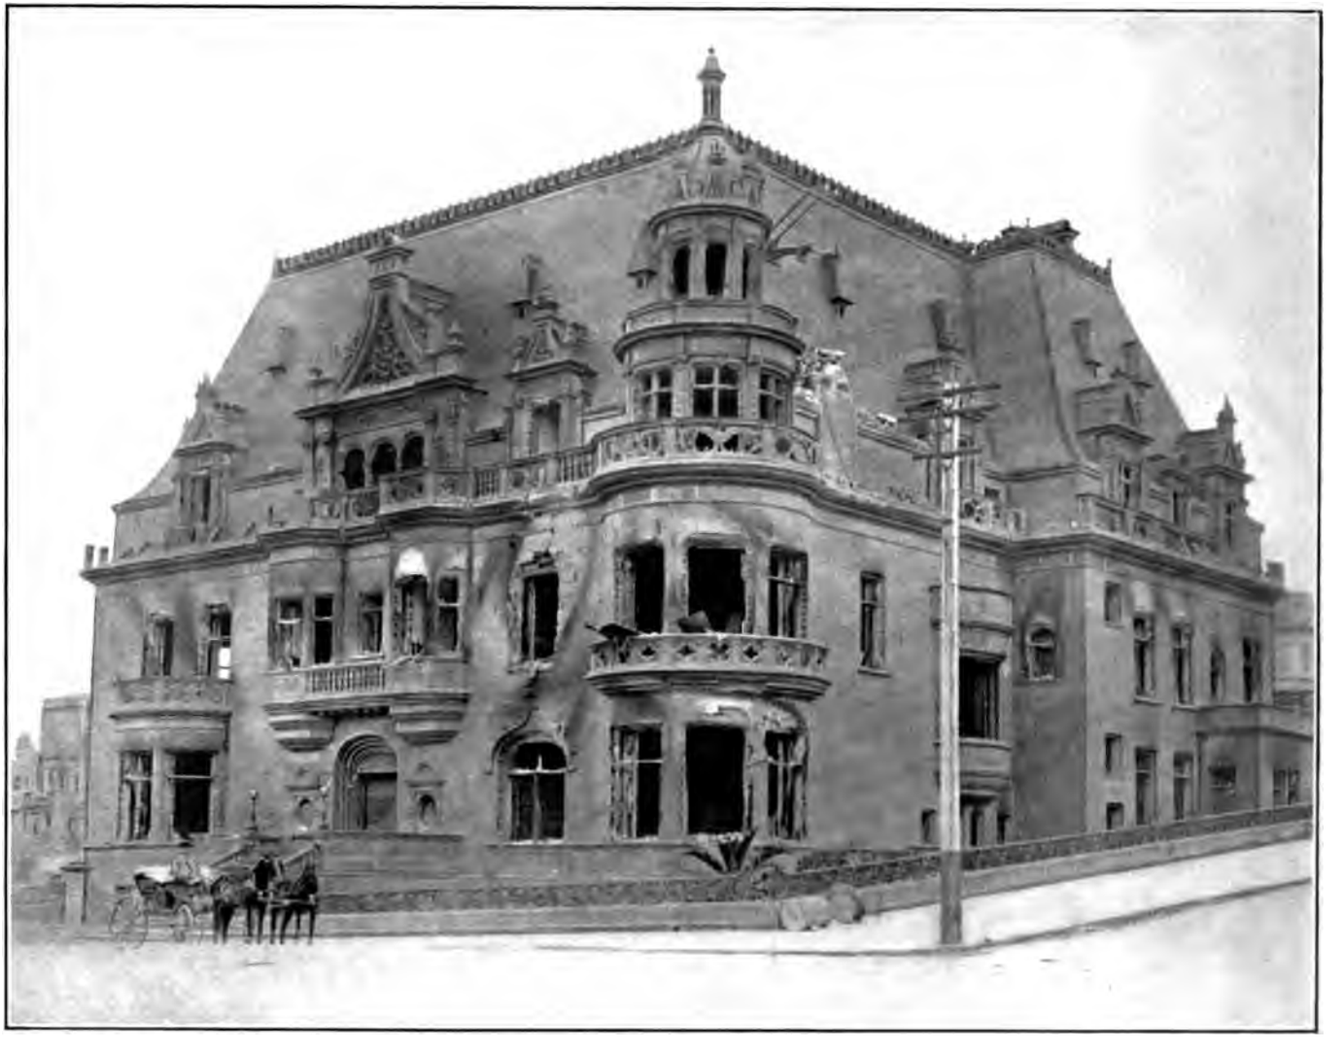
CLAUS SPRECKELS RESIDENCE. Southwest Corner Clay Street and Van Ness Avenue. The façades of brown stone are badly spalled around the window openings. The earthquake damage to the walls is slight. This was the only fire-proof residence in the burned district.

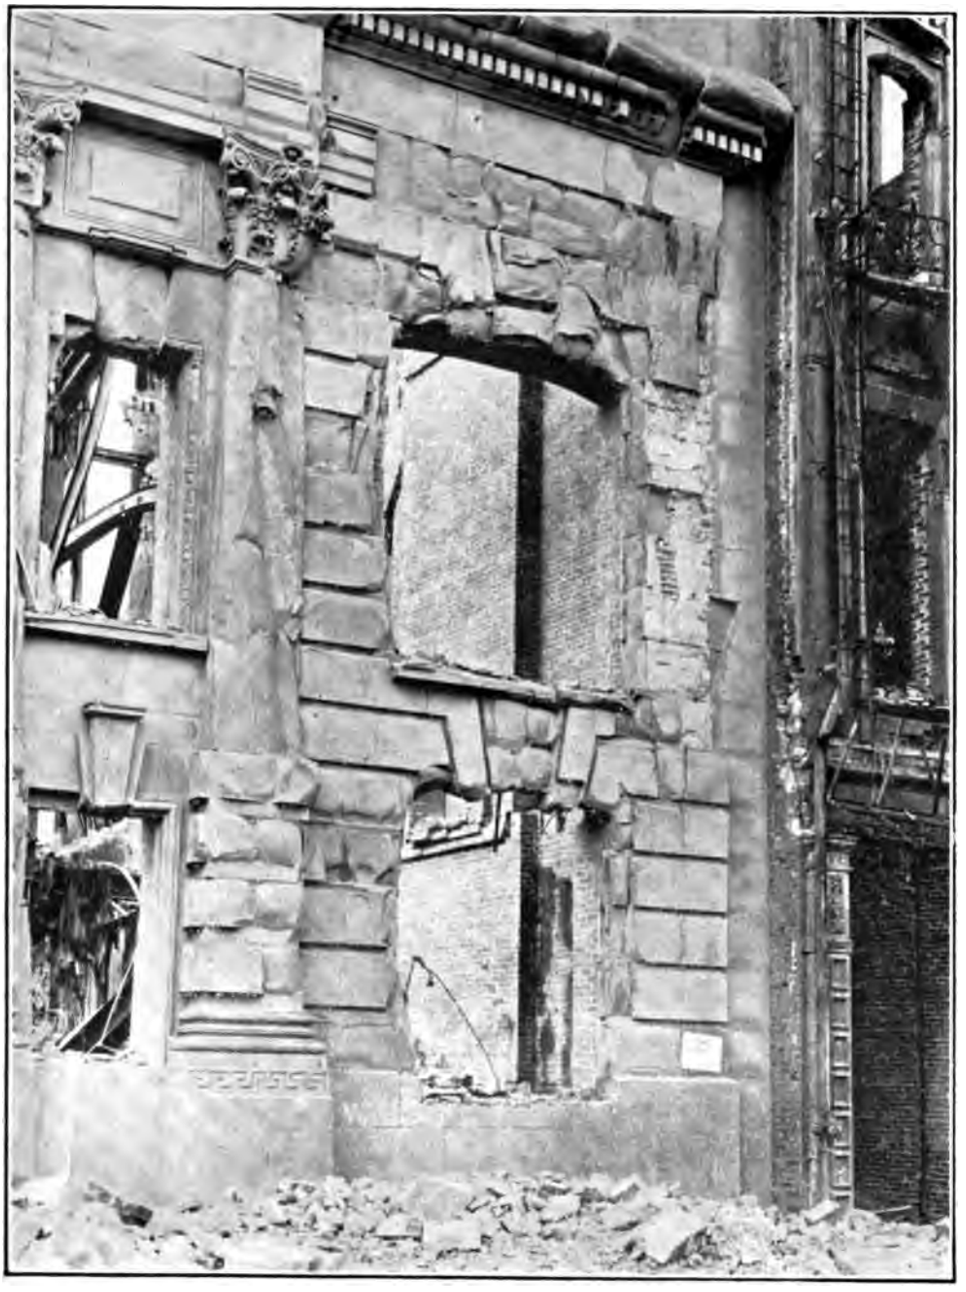
SPALLED RED SANDSTONE. Northeast Corner Post and Stockton Streets. Showing a portion of the Pacific Union Club's new building.

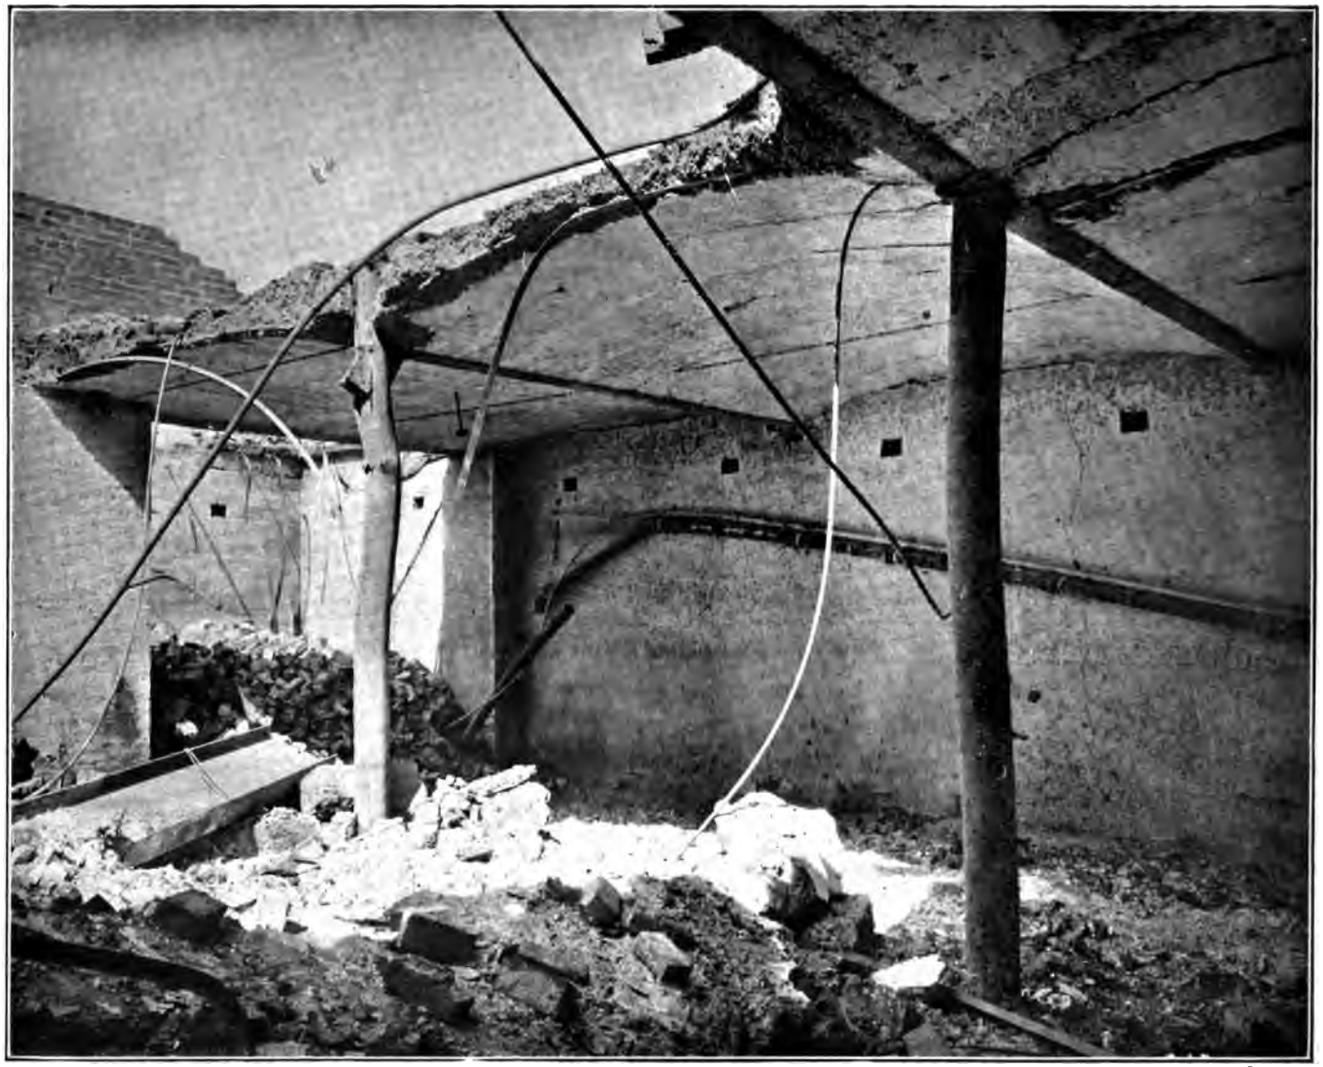
VAULT of the Bancroft-Whitney Publishing Company. In the rear of a building on California Street between Kearny and Dupont Streets. A Standard Underwriters' metal covered door separated this vault from the basement of the building. The fire destroyed the door, igniting the contents of the vault, causing the total and partial failure of the cast-iron columns, and the failure of a section of the concrete arches supported by them. A double fire-proof barrier in the door opening of this vault would probably have saved the contents.
